Manhole Inspection Summary

Manhole # S09GG2022MH

Insp Date: **10/30/06 11:27 AM**

Location Address: **6200 IVYMOUNT RD**

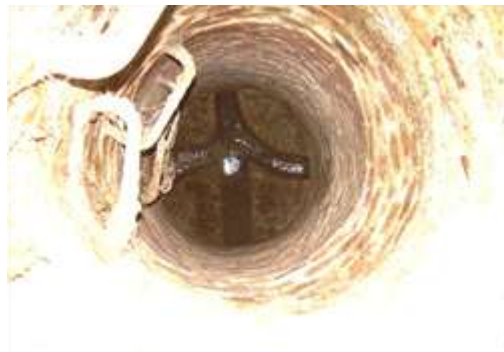
Top View

Evidence of surcharge - Bench debris. Channel debris. Corroded steps.

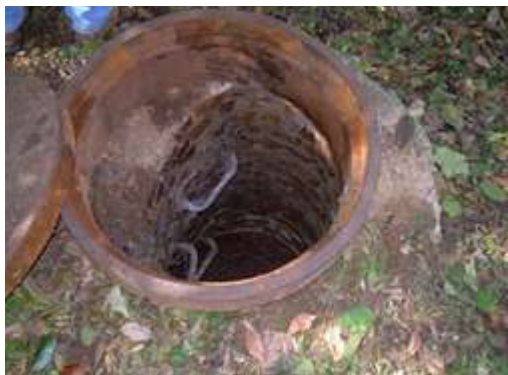
Defect

Comments **The Manhole frame is loose - not attached to the manhole. It seperates when the manhole is opened.**

Frame offset. Frame leaks. Unattached frame.

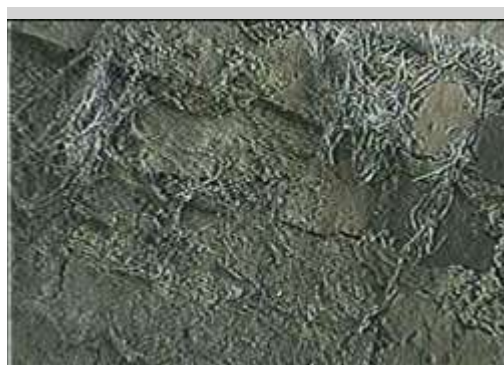
Defect

Adjustment deterioration, root intrusion and infiltration.

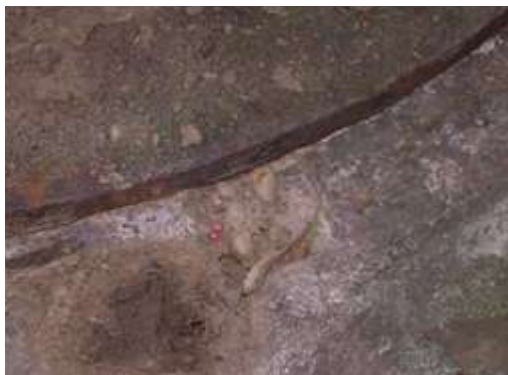
Defect

Unattached frame.

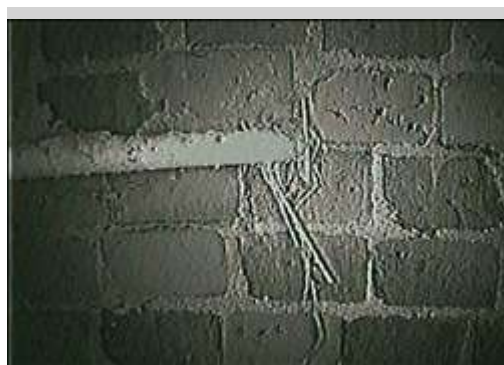
Defect

Corbel root intrusion.

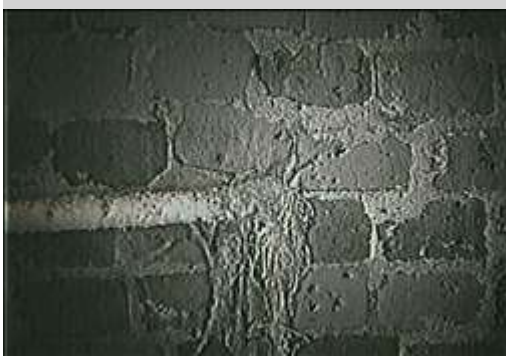
Defect

Evidence of surcharge.

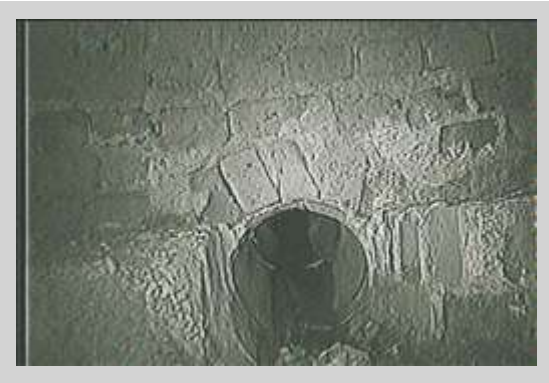
8 in. Circular Gravity Sewer Pipe Out @ 12 O'Clock

Deposits: ☐ None ☐ Mud ☐ Sludge ☒ **Debris** ☐ Grease

Silt Depth: **0** (in.) Deposits Extent: **Light**

Infiltration: **Evidence** Pipe Seal Cond: **Cracked**

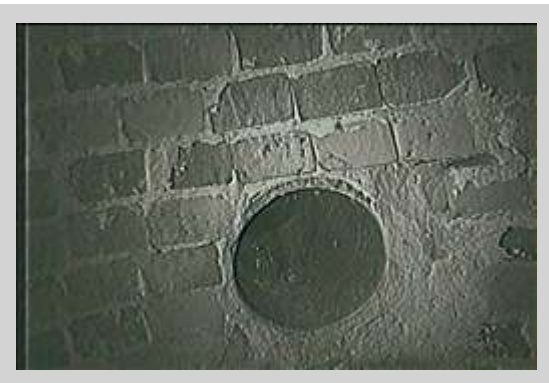
8 in. Circular Gravity Sewer Pipe In @ 3 O'Clock

Infiltration: **Evidence** Pipe Seal Cond: **Unknown**

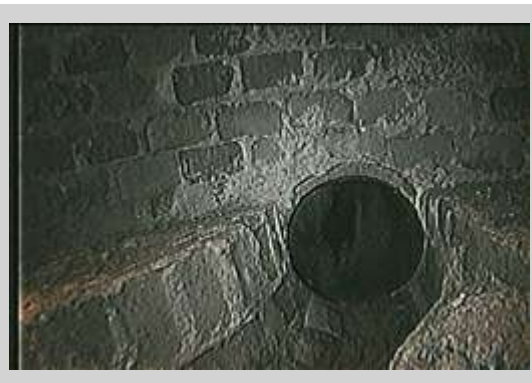
Drop In @ 3 O'Clock

Channel deterioration.

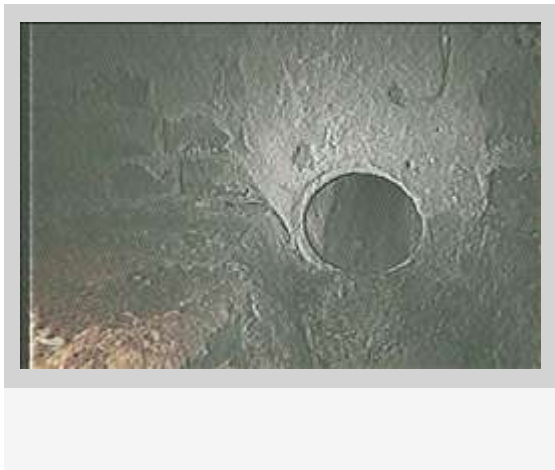
6 in. Circular Gravity Sewer
Pipe In @ 9 O'Clock

Infiltration: **Evidence** Pipe Seal Cond: **Unknown**
